## Coronary CTA and Arrhythmia Overcoming the Unexpected

**ONE**  
*Aquilion*  
dynamic volume CT

Case Study Brochure  
Hong Kong Sanatorium & Hospital

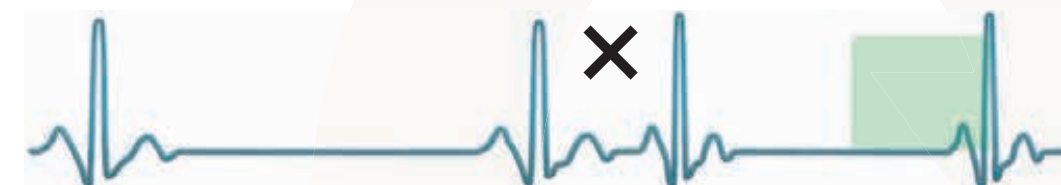
Arrhythmic Beat: Premature Ventricular Contraction

In the example below, the patient experiences a premature ventricular contraction (PVC) during the scan. A PVC is characterized by a very short heartbeat and is followed by a compensatory long heartbeat. The software recognizes this pattern and aborts the exposure in the abnormal beat. In order to ensure that a motion-free diagnostic scan is obtained in the next beat, the exposure window is extended to include the next R wave to make certain that the diastolic phase is captured. As a result, the examination is diagnostic, and a failed examination with wasted X-ray exposure is avoided.

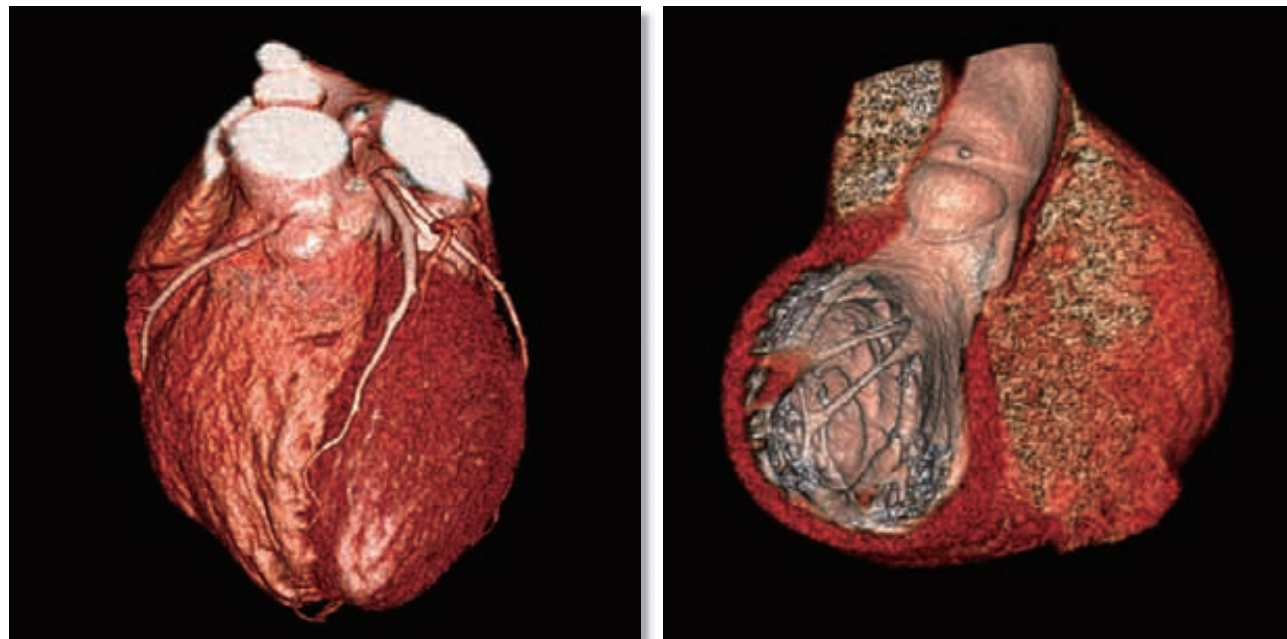
The right coronary artery arises from the ascending aorta just above the right coronary sinus, as shown in these 3D images.

Despite the arrhythmic beat during the scan, diagnostic images could be obtained in this case. An anomalous origin of the right coronary artery above the right coronary cusp was demonstrated in this scan. This anomaly is considered to be benign.

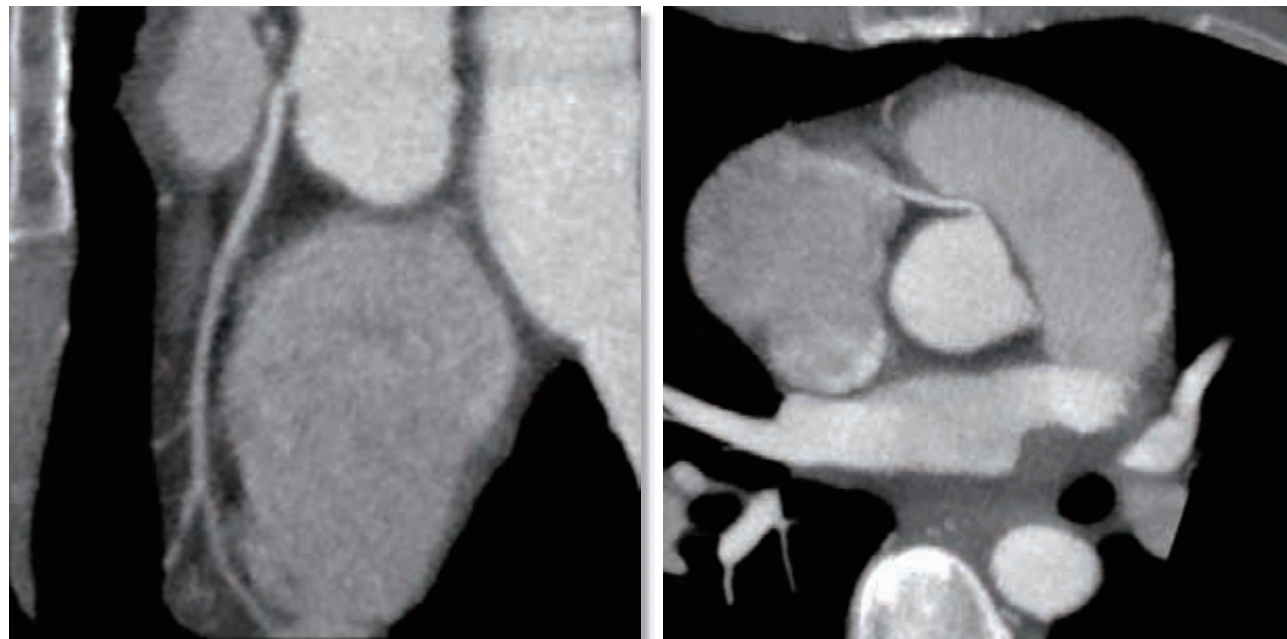
The RCA arises from the ascending aorta immediately above the right coronary cusp. This anomaly is considered to be benign.

This scan demonstrates an anomalous origin of the right coronary artery. This anomaly is considered to be benign.
